Customer: LSX

Date: 01/14/2021

Injector Cleaning Service Data Sheet								
Injector #	1	2	3	4	5	6	7	8
Resistance in Ohm	7.1	7.1	7.2	7.2	7.1	7.1	7.1	7.2
Leak Test	Pass	Fail	Pass	Pass	Pass	Pass	Pass	Pass
Pass/Fail	Pass	Pass	Pass	Pass	Pass	Pass	Pass	Pass
Spray Pattern	Good	Poor	Good	Good	Good	Good	Good	Good
Good/Fair/Poor	Good	Good	Good	Good	Good	Good	Good	Good
Static Flow Before	2100	1980	2160	2040	1920	1860	2160	2040
Static Flow After	2200	2250	2220	2230	2200	2220	2250	2200
Flow In LB/HR	209.52	214.29	211.43	212.38	209.52	211.43	214.29	209.52
% Change Per/Injector	4.76%	13.64%	2.78%	9.31%	14.58%	19.35%	4.17%	7.84%
Test Pressure (PSI)	43.5	Before		After

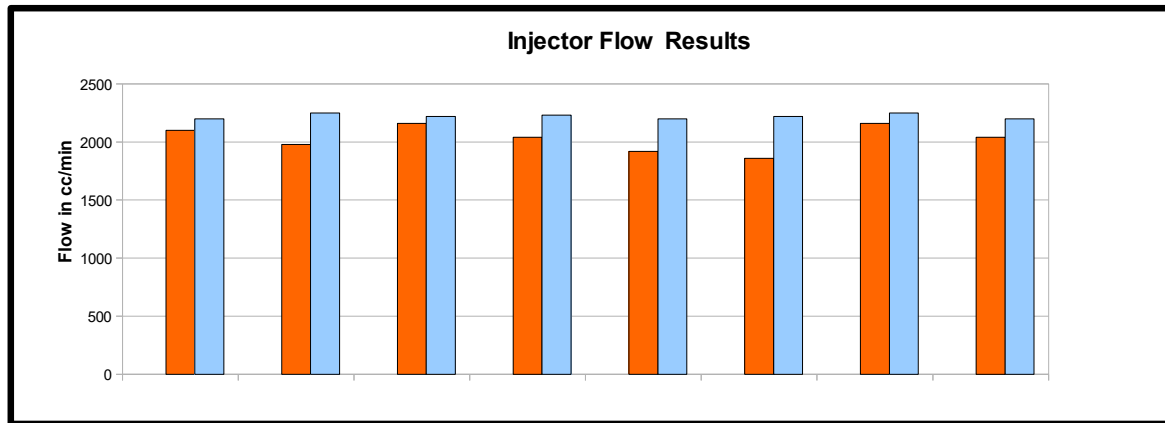
#2 injector was leaking and did not have good spray pattern when arrived

Parts Replaced			
Part	Qty	Part	Qty
Filter Baskets	0	Bottom Seals / O-Rings	8
Pintle Caps	0	Cushions	0
Top Seals / O-Rings	8	Spacer	0
